SUBJECT: IMPROPER EXPENDITURE OF DEPLETED URANIUM MUNITIONS

This letter is submitted per 10 CFR 30.50 as an initial report to an incident which occurred on February 19, 1999, concerning depleted uranium (DU) ammunition expended on the Live Impact Area of the Vieques Naval Range, Atlantic Fleet Weapons Training Facility, Naval Station Roosevelt Roads, Puerto Rico.

Report of Depleted Uranium Recovery Operations

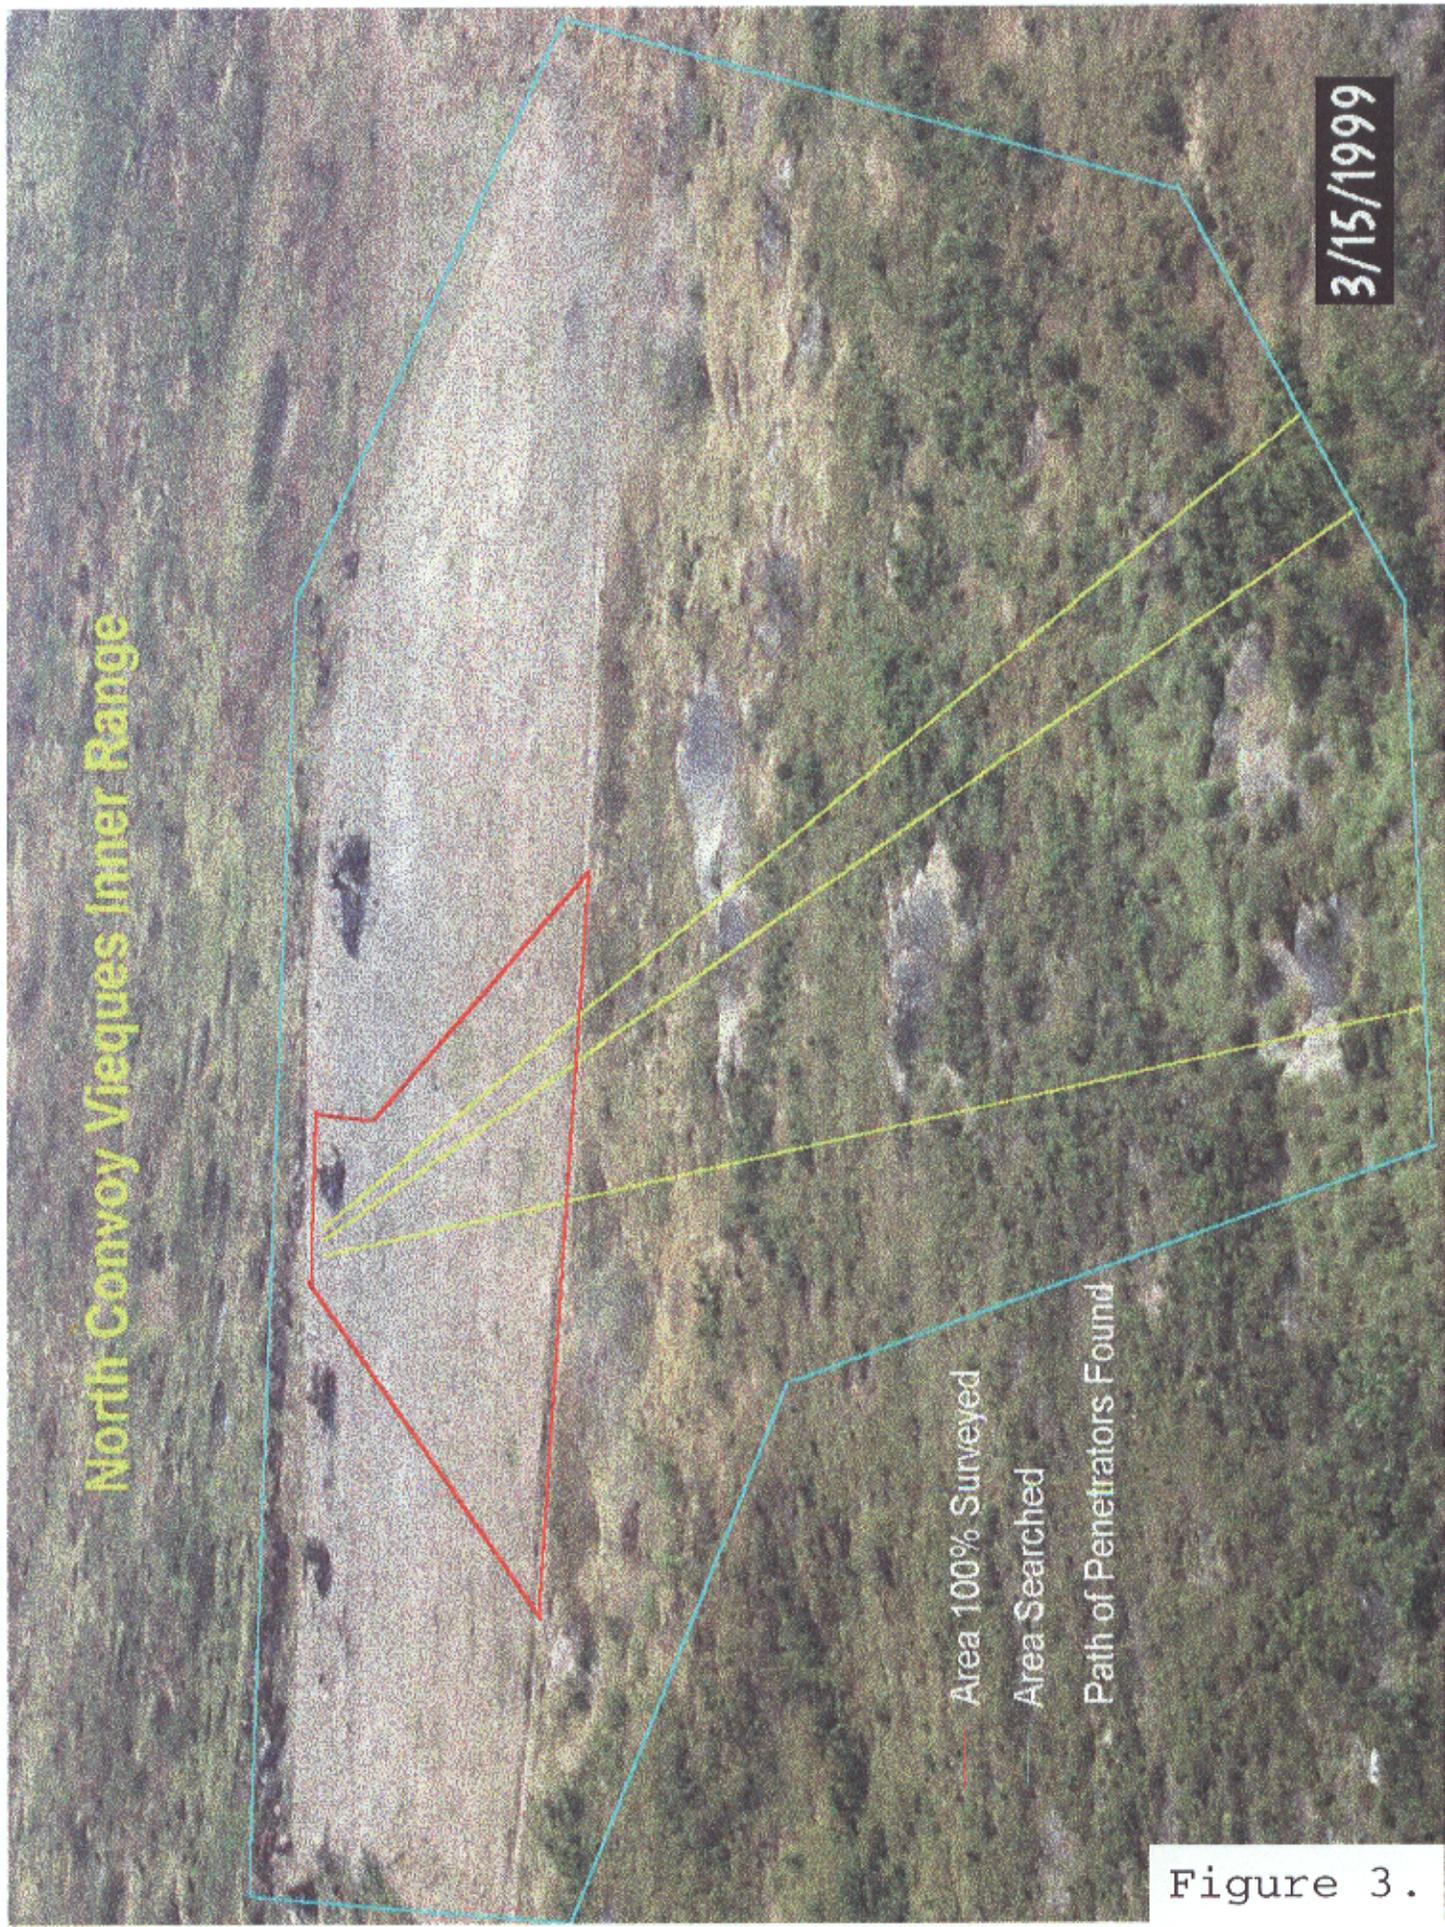
Figure 3.

A total of 57 DU penetrators were recovered, most of them completely intact, and located within the shrubbery and grass just north of the North Convoy target area (reference Figure 3). Only a few holes exhibited residual contamination after the penetrator was removed. In each case, part of the penetrator

A thorough radiological survey of the affected area, out to the perimeter of the vegetation, was conducted using a 2" X 2" sodium iodide detector following the recovery of all penetrators (reference Figure 3). No additional penetrators or residual contamination were noted as a result of the radiological survey. Due to the dense vegetation and the possibility of hidden unexploded conventional ordnance, surveys were limited to the immediate vicinity of the North Convoy target site. Visual and radiological surveys were conducted at several other target sites on the Live Impact Area to confirm that only the North Convoy site was involved. No penetrators or contamination were found at these sites. All recovered penetrators and contaminated soil have been placed in containers and securely stored until proper disposal can be arranged.
