# Naval Audit Service

# Consideration of Hazardous Noise in the Acquisition of the CVN 78 Aircraft Carrier

N2009-0022  
19 March 2009

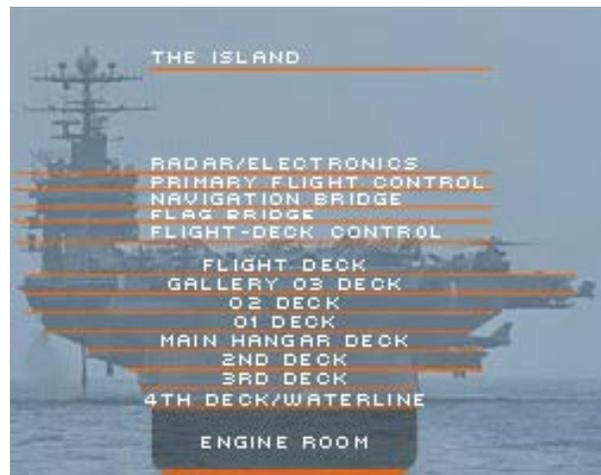
According to the Naval Safety Center, other noisy areas on aircraft carriers include the gallery deck (see illustration), located directly below the flight deck, and other workspaces, such as machinery rooms. Sources of airborne noise on the gallery deck include jet noise, as well as catapult, jet blast deflector, and arresting gear equipment. According to the Naval Safety Center, airborne noise levels on the gallery deck, where

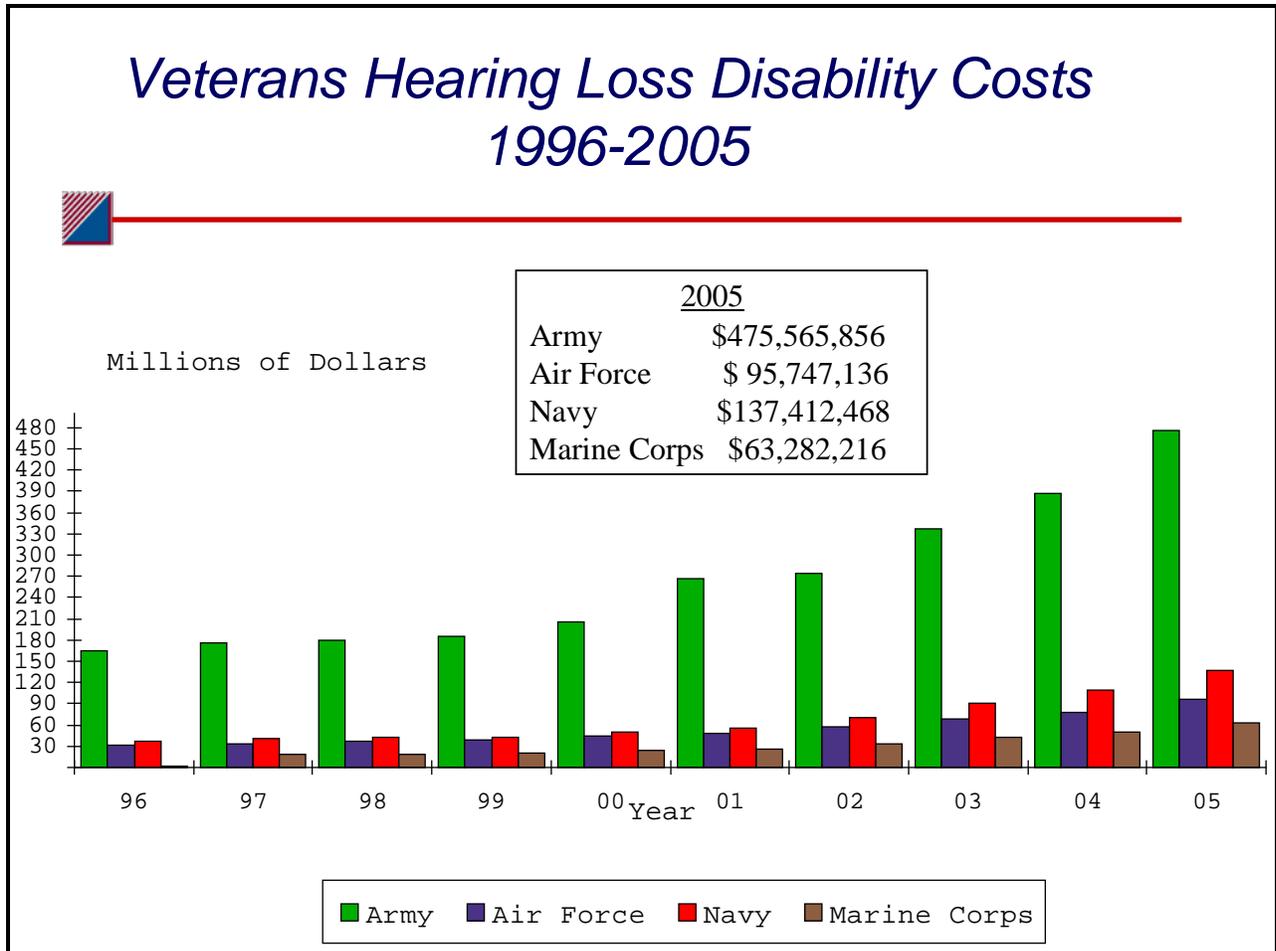
# Center for Naval Analyses Veterans Hearing Loss Disability Costs

Source: Center for Naval Analyses, "Computing the Return on Noise Reduction Investments in Navy Ships: A Life-Cycle Cost Approach," September 2006.

sailors live and work, can exceed 100 dB. In addition, ventilation systems, auxiliary equipment, and the ship's propeller also contribute to airborne noise. According to the Naval Safety Center, continuous exposure to hazardous noise levels reportedly leads to hearing loss. Furthermore, the Center for Naval Analyses reported that from 1996 to 2005, total Navy disability costs associated with hearing loss have steadily increased. The cost in 2005 was approximately \$200.7 million (see Enclosure 4) for DON.
