EXECUTIVE SUMMARY

This Comprehensive Review (CR) examined the facts, circumstances and processes surrounding the recent Physiological Episodes (PEs) involving T-45 and FA-18 aircrew, including how these issues have been addressed. While conducting this examination the CR review included:

FA-18 OVERVIEW

T-45 OVERVIEW

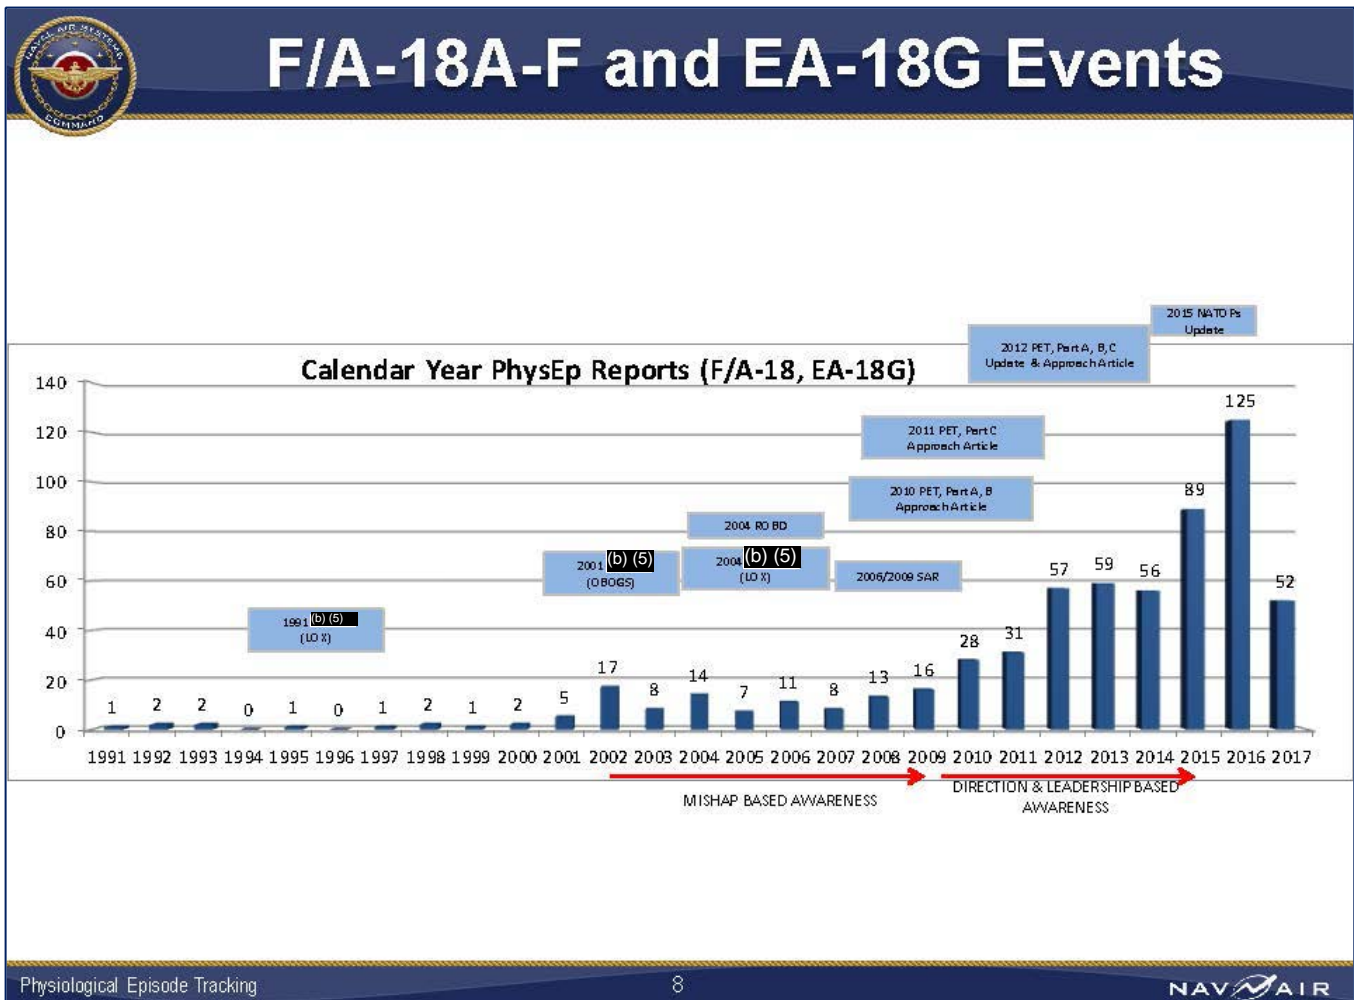
community: 31 in calendar year 2011; 57 in 2012; 89 in 2015; 114 in 2016; and 52 to date in 2017.¹³ Figure 1 below depicts reports of PEs in FA-18s by Calendar Year. The increased number of reports can likely be attributed, in part, to increased awareness throughout the Fleet regarding the PE phenomenon and the realization of the potentially dire consequences of a PE. Contributing to this increasing awareness were: joint NAVAIR – NAVSAFECEN presentations provided to FA-18 aircrew at Whidbey Island, Lemoore, Beaufort, Miramar, Atsugi and Fallon; NAVSAFECEN new reporting guidance in a naval message;¹⁴ an increased focus on PEs from the NAVSAFECEN during Squadron Safety Assessments; and continued engagement between the Physiological Episode Team (PET) and the Fleet.

Figure 1 – FA-18 Physiological Episodes by Calendar Year

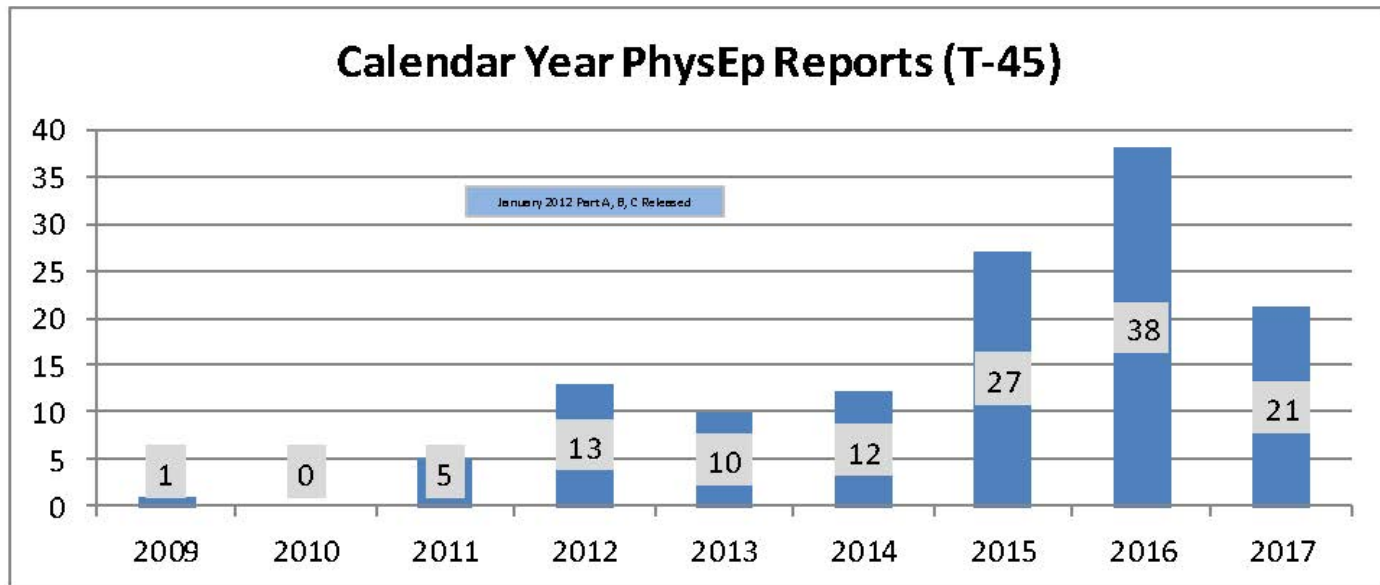
As previously discussed, the apparent PE increase in 2010 was likely more reflective of a change in aircrew awareness and reporting mechanisms than a sudden rise in PEs. Thus, comparison of pre- and post-2010 PE could lead to inappropriate conclusions. Since December 2011 there have been 112 T-45 PEs. Of these, 81 have been adjudicated by the Naval Aviation Enterprise (NAE). Analysis of the remaining 31 PEs is ongoing. Of the 81 adjudicated cases, 48 percent were determined to be aircraft system failures or human factors (i.e., fatigue, diet, procedural error); 28 percent were determined to be possible contamination; 24 percent were determined to be inconclusive.³⁰ Figure 2 below depicts reports of PEs in T-45s by Calendar Year. The aircraft system failures include two documented pressurization PEs since May 2016.

Figure 2 – T45 Physiological Episodes by Calendar Year
