TRIESTE II DIVE 3

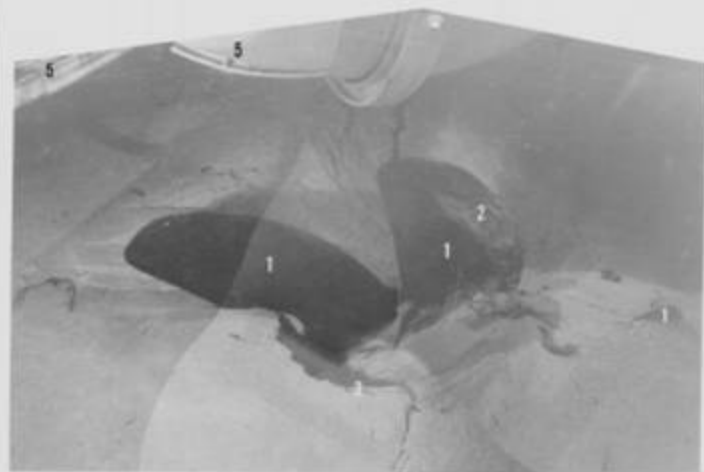
FIG 1

FIGURE 1 is a mosaic compiled from TRIESTE II photography showing two blades and the tip of a third blade of a seven-blade propeller. The pressure sphere of TRIESTE II is also visible.

1. Propeller blade
2. Scratched or abraded area
3. Crater edge
4. Propeller shaft
5. TRIESTE II structure

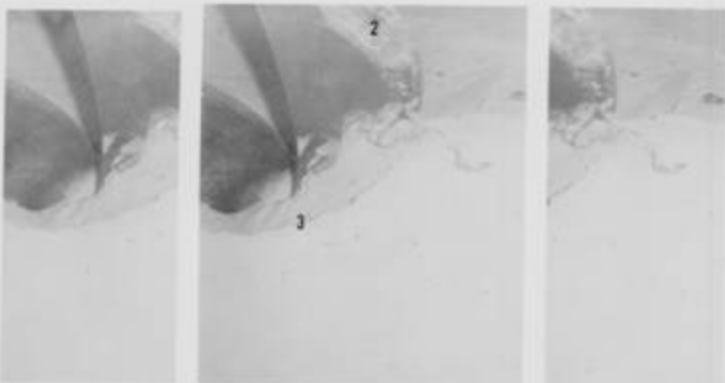
FIG 2

FIGURE 2 is a stereo triplicate showing the scratched or abraded area of the visible blade. The sharp edge of the crater over the hub of the propeller is also visible.
